Using the Land Health Standards to Assess Reclaimed Mine Sites

By Jony Cockman

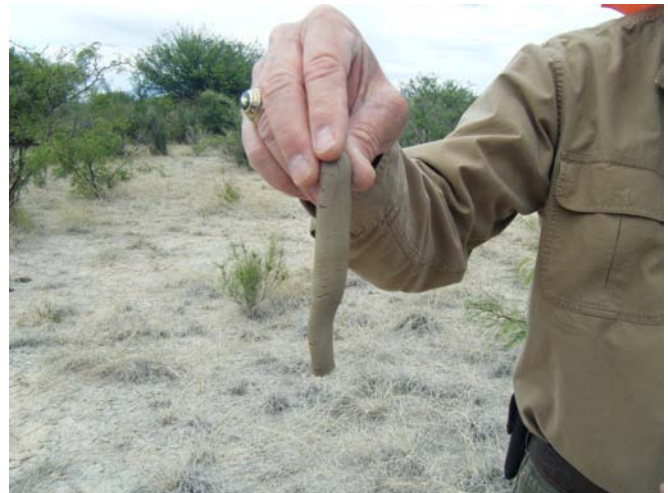
Mine tailing has the texture of clay but has different chemical properties from clay.

The cap material on Pima Tailing 6 ranges from 4 to 6 inches deep. New projects will have thicker cap material (at least one foot thick). The tailing material has the texture and similar water holding capacity of heavy clay, but is not chemically similar.

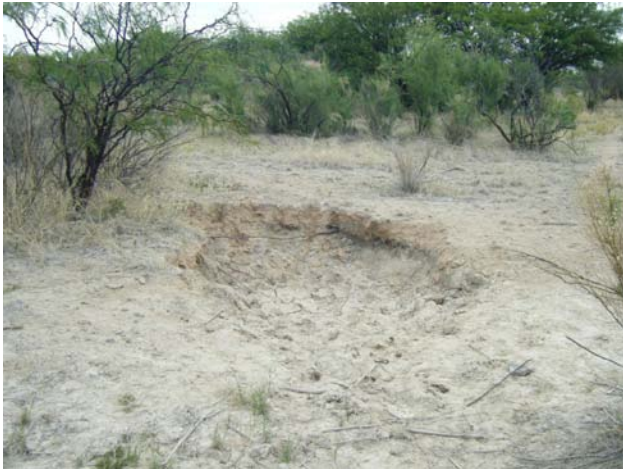
Tailing subsidence created a depression that filled with water and has been used as a stock pond by local cattle and wildlife.

One peculiarity that had to be assessed for Pima 6 Tailing hydrology was tailing subsidence. This is a natural feature on the tailing as the tailing continues to dry out. Tailing subsidence is a unique feature not discussed in the land health assessment matrix. The tailing dam is a contained unit with no outlet. If there were an outlet for hydrologic flow then the subsidence features could develop into pipes, rills and gullies with massive erosion associated. However, within the enclosed system the subsidence is seen as a natural feature.

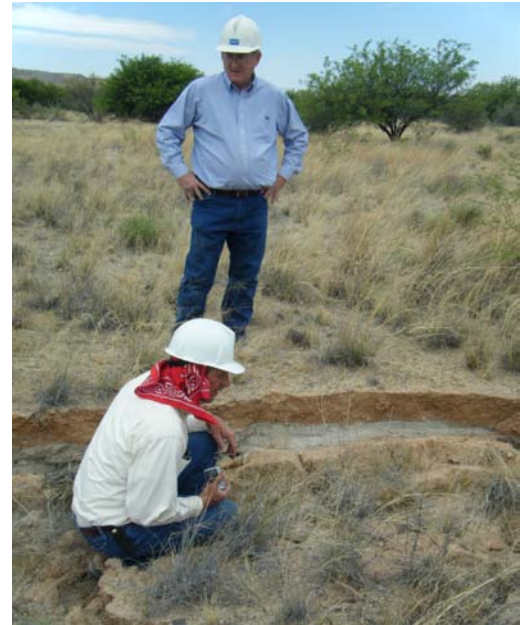
Several inches of dark colored cap material cover lighter colored tailing at Pima 6 Tailing. A subsidence feature is examined by Dan Robinett (contractor) and Al Richins (ASARCO).

Indicators 8) soil surface resistance to erosion and 9) soil surface loss and degradation could not be examined in the traditional sense. The cap material on Pima 6 Tailing averaged four to six inches deep and supported a variety of vegetation. When fresh cap material is put in place on new projects it will have a larger percentage of rock and gravel which will provide protection from wind and water erosion.
